NEWSLETTER HEGGEL® Fix 831

December 2021

Innovative Repair & Refurbishment Technology

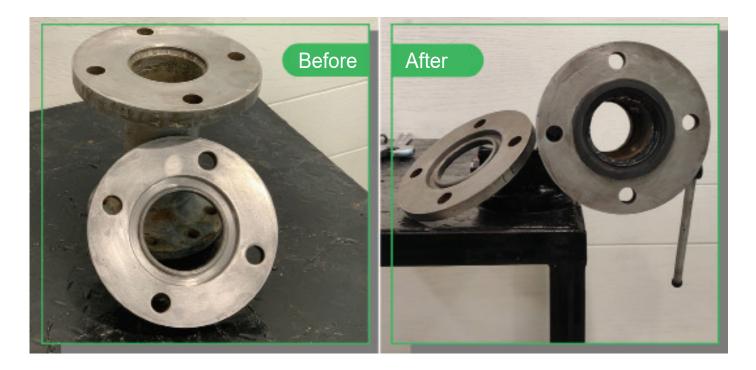
Flanges, used to connect pipes, valves, pumps, etc, are indispensable part of different segments. Given the extreme conditions that process facilities often encounter, flanges are exposed to a variety of defects including corrosion, pitting, denting, gouging, etc. Such defects may result in flange leaks and in case of more severe damages, creating hazard and eventually unplanned shutdown. To fix defects like corrosion damages on flange face **HEGGEL Fix 831** is a proven solution by which restoration of corroded parts is achieved and strong sealing is provided.

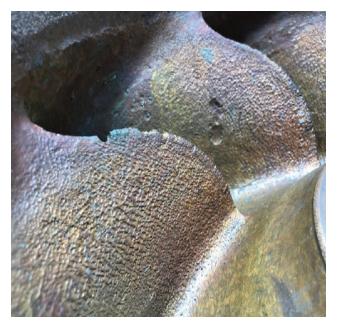
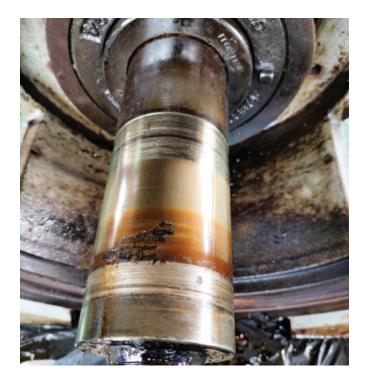
Shafts are crucial components in machines and devices with several important uses in high-performing industrial applications. generating force in a broad range of mechanical equipment. They are extensively subjected to deteriorating mechanisms including corrosion, wear, overload fatigue leading and to cracks. brittleness, ratchet marks, etc., causing considerable material loss and overall reduction of shaft diameter. Also, crack growth induced by pitting corrosion and material defects would contribute to shaft failure. HEGGEL Fix 831 can successfully build up the material loss and with superior mechanical strength, reliably repair extreme corrosion defects.

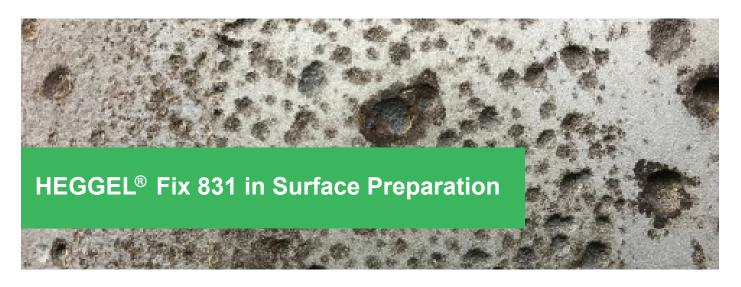
Cast parts are widely utilized in various industries since they can remain unused for extended periods of time and still show peak performance. Design flexibility and wide temperature resistance are among other interesting aspects of industrial applications of cast parts. However, casting defects such as misruns and cold shuts, unfilled sections, porosities, mocks, holes, cavities, shrinkages and crushes, are major points of concern. Here, **HEGGEL Fix 831** is also the applicable repair material to fully resolve these deficiencies.
