HEGGEL®

HEGGEL® Fix 811

April 2022

Rubber Lining Uniform Repairing Mortar

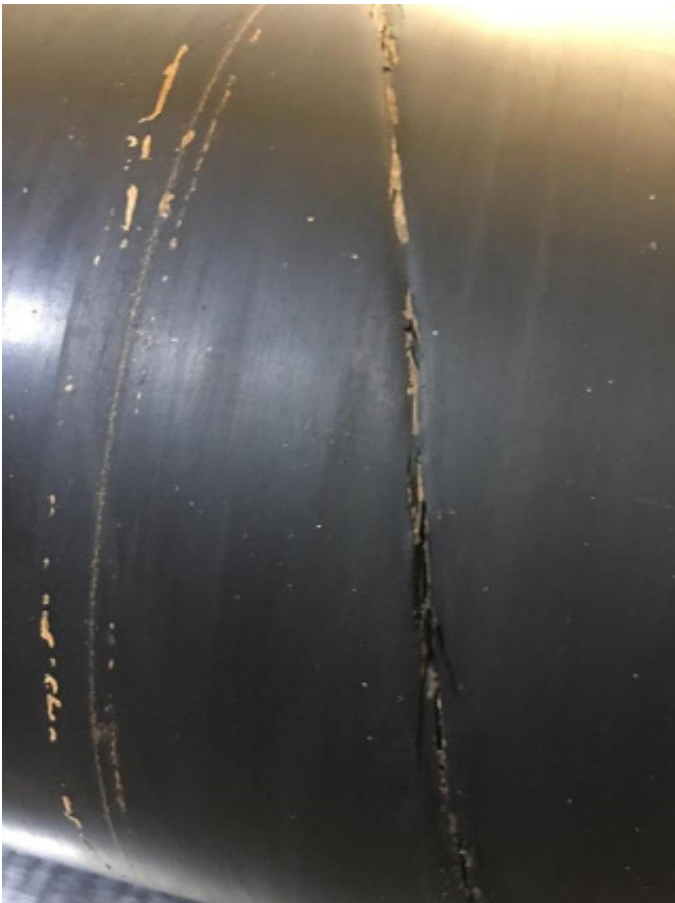
Rubber Lining Defects

Disregarding critical considerations in the long run may result in the failure of rubber-lined infrastructures. Even the best rubber linings could be damaged to some extent. Having been used for decades as a traditional corrosion protection method, the rubber lining of industrial assets has now encountered aging defects due to the long service life after being first installed. Moreover, problems with rubber-lined equipment may range from small blistering on the surface to large zones of delamination, dislocation, seam lift on corners / edges and eventual separation from the metal substrates. Damages caused by inadvertence in operational/mechanical processes as well as deep or surface effects of corrosion and erosion are among other defects. The situation is even more exacerbated through dynamic environments when the separated rubber from blistered or loose parts becomes abraded and causes major difficulties with industrial operations. Inspections should be regularly carried out to schedule maintenance operations in order to hinder the destructive consequences of corrosion.
