# NEWSLETTER HEGGEL<sup>®</sup> Fix 831

November 2024

Flange Protection in High-Risk Operations: Combating Corrosion, Wear & Downtime

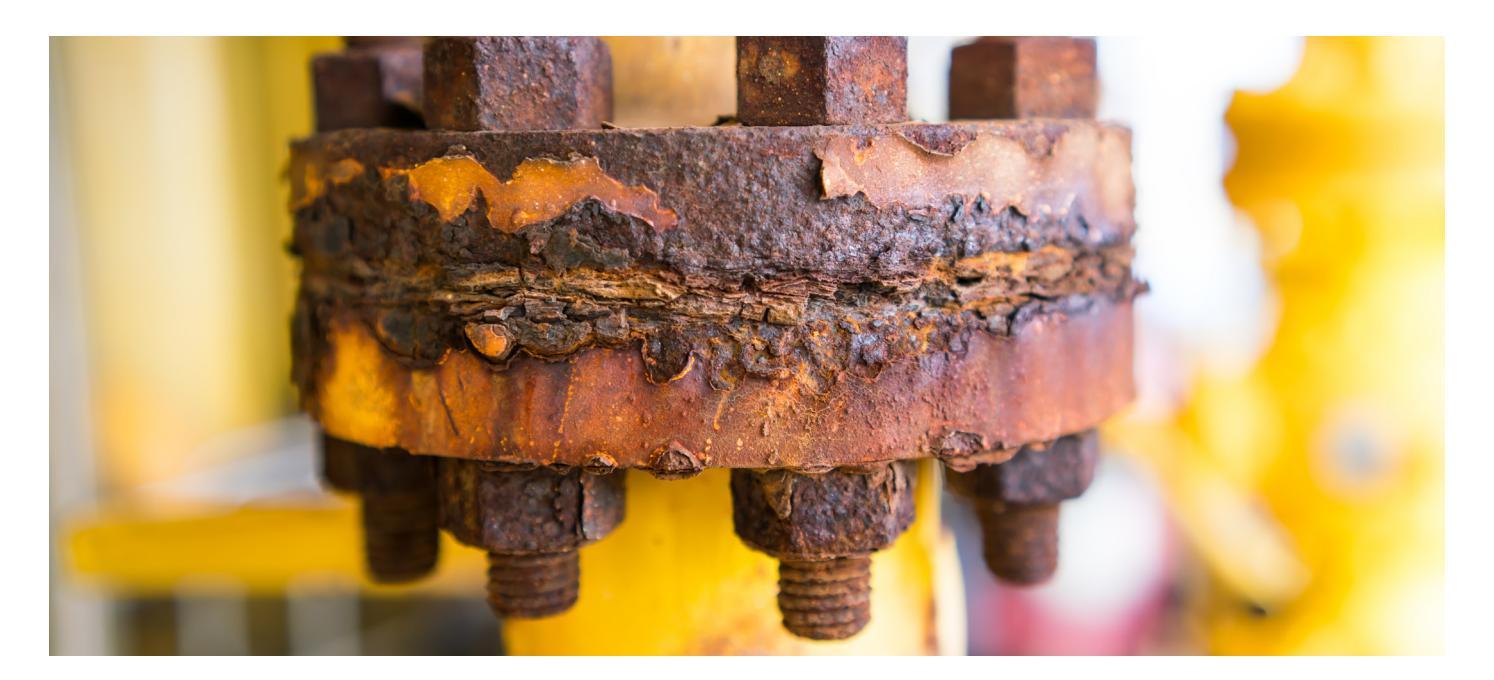
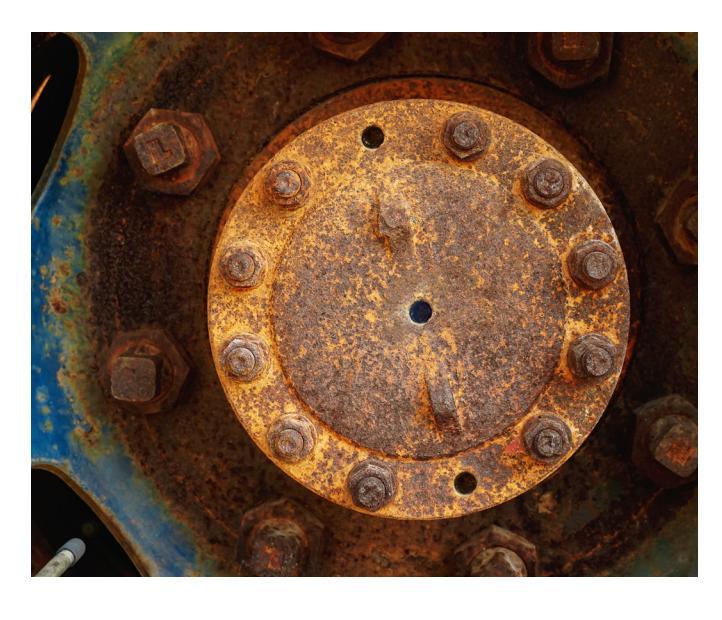
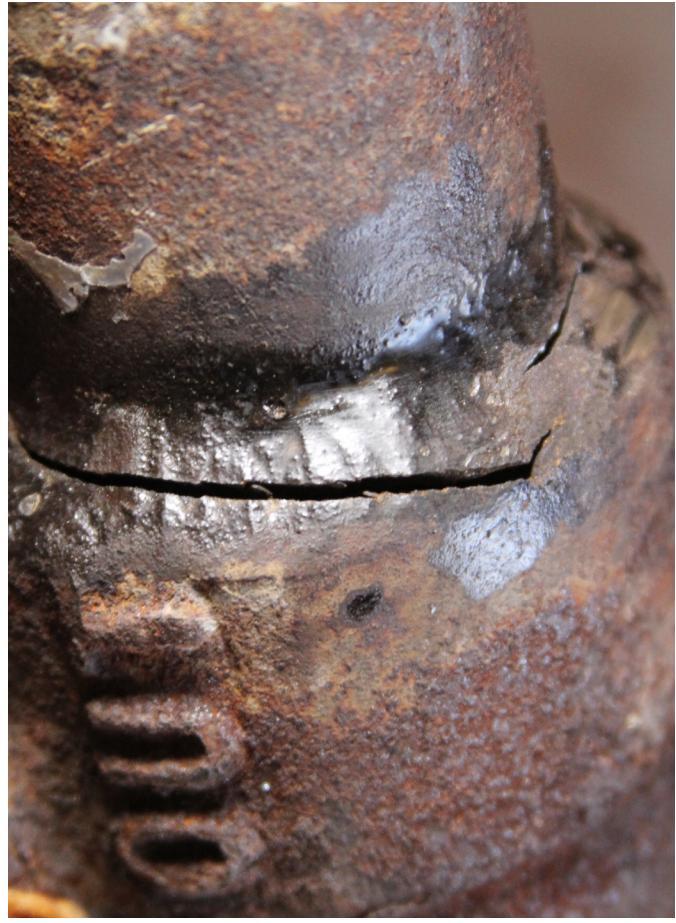
**Uniform Corrosion** affects the entire surface evenly, often due to constant exposure to corrosive environments like moist or acidic conditions in petrochemical plants. Although predictable, it gradually reduces flange strength over time. **Pitting Corrosion** creates deep, localized pits on the flange surface, typically from chloride exposure, as seen in offshore platforms and subsea pipelines. This form of corrosion is challenging to detect and can lead to leaks from weakened structural integrity.

**Crevice Corrosion** occurs in areas where moisture, chemicals, or contaminants become trapped, such as gaps in flanged connections. Common in pipelines and gas refineries, this type can compromise seal effectiveness, leading to leaks and pressure drops. **Galvanic Corrosion** develops when dissimilar metals come into contact in an electrolyte, accelerating corrosion at the anodic metal. Often found in mixed-metal flange assemblies in offshore platforms, this type can weaken the metal and result in flange failure.

**Stress Corrosion Cracking (SCC)** combines tensile stress with a corrosive environment, leading to cracking, especially in stainless steel flanges in high-temperature, high-pressure settings like gas refineries. These cracks can quickly spread, causing sudden and potentially catastrophic failures. Lastly, **Erosion Corrosion** results from the flow of corrosive fluids at high velocities, which physically erodes the flange surface while corroding it. This type, common in pipelines, can thin the flange and lead to seal failure and leaks.

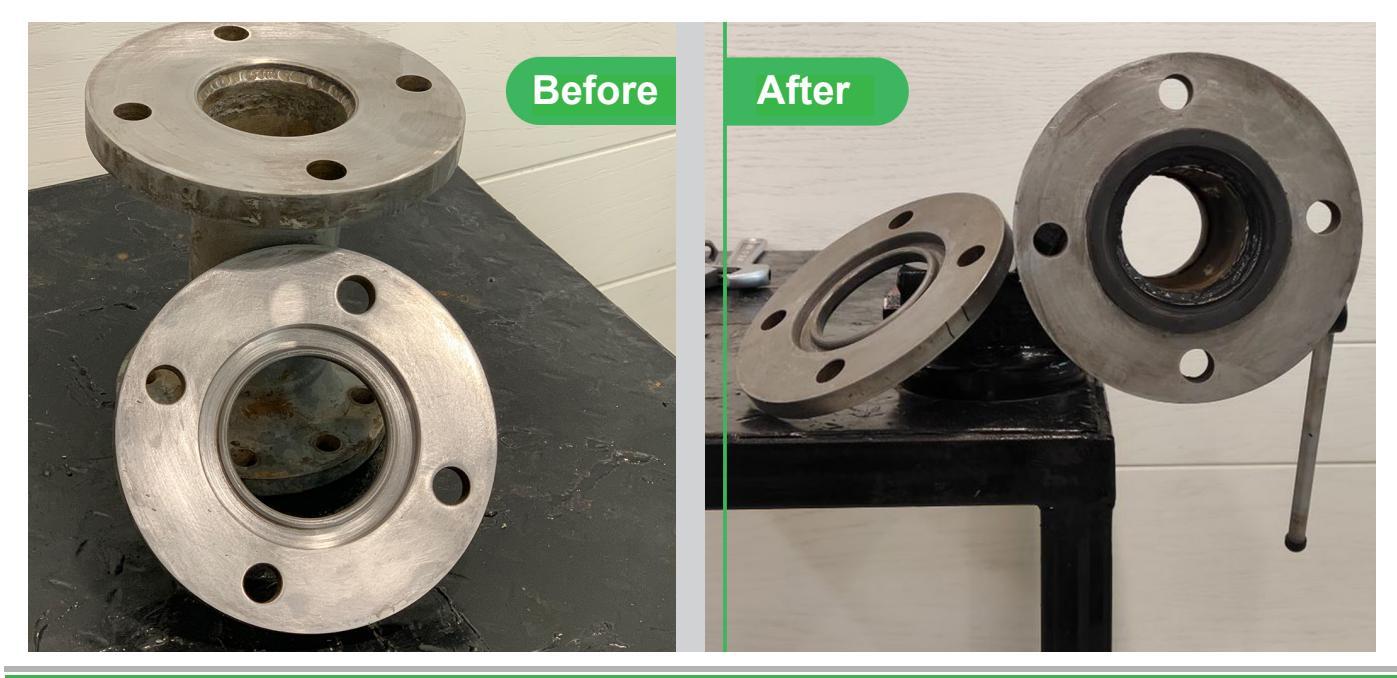
The accompanying before-and-after images offer a compelling visual testament to the remarkable transformation achieved through these innovative techniques.

To confront these problems, **HEGGEL Fix 831** provides a state-of-the-art solution for effectively combating flange face corrosion. By employing modern protective technologies, this highperformance composite repair system not only restores damaged flange faces to their original integrity but also ensures long-term resistance to future corrosion. This advanced solution bolsters the durability and reliability of flange systems, significantly reducing maintenance costs and preventing operational disruptions.
